DEALER SERVICE BULLETIN

Number: DSB 10-0015

Title: SCT (Saturated Condenser Thermister)
Improvements

Carrier: 48PGxC04~28; 50PGxC04~28

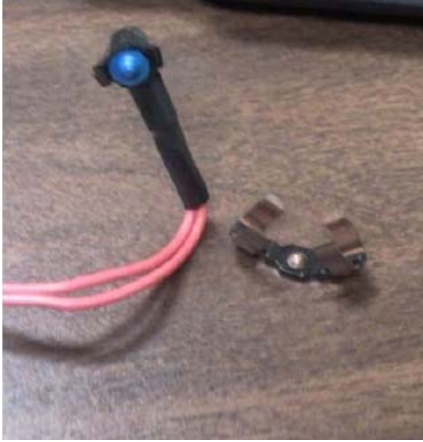
Figure 1

There have been reports indicating cracking failures of the Saturated Condenser Thermisters (SCT) HH79NZ036 on 48/50PG04~28 Centurion units listed above, warranting a review of the sensor's design. Fractures were noted between the "T" bar clamping clips or fastener head, and where the embedded thermister resides (figure 1). Findings indicate that seasonal environment swings along with wire weight stress contributed to the fractures. This failure caused the SCT to not make proper contact with the copper tubing, diminishing the sensors ability to accurately sense the saturated condensing temperature. This failure directly affects the units ability to control the staging "ON and OFF" of the condenser fan motors to maintain proper condensing temperatures.

If the SCT HH79NZ036 fails within the serial number range listed, replace the failed sensor with part number HH79NZ100. The new sensor comes with 96" wire leads for full wire and routing replacements. However, a second removal and replacement process has been developed.

To replace a failed sensor cut the failed SCT sensor wires (2) 18" from the sensor, remove old sensor, leaving wires from control box in-place. Cut the new SCT wires 24" from sensor end, strip the wires back 1/2" from both sets of wires (from the control box and new SCT). Slide "Heat Shrink" wire tubes over a set of wires. Using two 18~22 ga. "butt connectors" attach and crimp both set of wires together, then slide the heat shrink tubes over the butt connectors and shrink. Clip the new SCT sensor to the same location on the coil as the failed sensor.
